Assil A. Russell, Nicholas P. Chandler, Lara T. Friedlander

Vertical root fractures in root canal-treated teeth

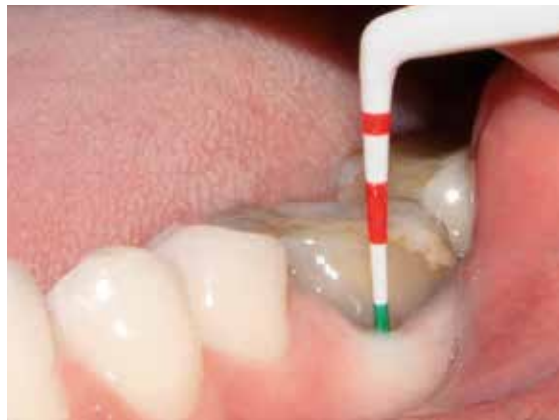
**Fig 1** PerioWise probe exploring for presence of a VRF.

The majority of late-stage VRFs present with a deep, vertical step, osseous defect that can be detected using a periodontal probe (Fig 1)^{15,18}. The probe can usually be inserted into a narrow pocket that extends to the deepest point of the fracture line¹⁵. A non-metallic periodontal probe (e.g. Perio-Wise, Premier Dental Products, Plymouth Meeting, PA, USA) is valuable for the detection of these periodontal defects. It is important for clinicians to distinguish between pocket probing depths in VRF and periodontal disease. In VRFs, the pocket is usually isolated and limited to the site of the fracture, whereas in a patient with periodontitis more sites and multiple teeth with generalised pocketing are expected. In the early stages of a VRF, there may be insufficient time for an osseous defect to occur

and thus probing can give a false-negative result. Although probing patterns are helpful, they are not totally diagnostic and should be used in conjunction with other aids.

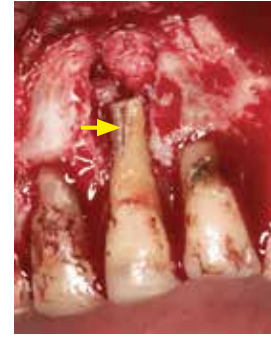
Fig 2 Intraoral photograph of a surgical site showing VRF (arrow), loss of buccal bone, and associated soft tissue lesion.

visual inspection^{15,17,18}. This often entails raising a full thickness mucoperiosteal flap to locate a fracture line (Fig 2). Lustig et al (2000) carried out surgical exploratory procedures on 110 teeth to study the pattern of bone resorption associated with VRFs¹⁸. They reported two main types of buccal alveolar bone resorption: dehiscence and fenestration. Dehiscence was described as a triangular V-shaped defect, which pointed apically and occurred in 91% of the teeth studied. Fenestration only occurred in 9% of the teeth and was described as an oval-shaped defect with an intact bridge of coronal bone. Fenestration bone resorption is said to occur when the VRF is located along the root, but does not extend to the cemento-enamel junction or apex¹⁸.
